**Moorhead Area Public Schools
Facilities Master Plan
Final Report**

February 23, 2015

Moorhead Independent School District 152
2410 14th Street South
Moorhead, Minnesota 56560

Cunningham Group Architecture, Inc.
St. Anthony Main
201 Main Street SE, Suite 325
Minneapolis, MN 55414

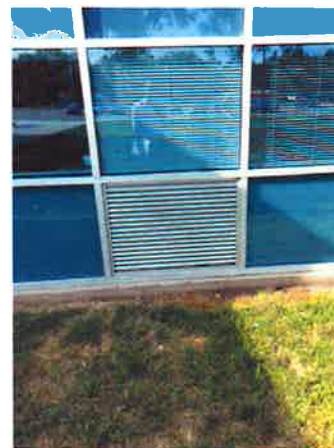
Curtain wall - exterior ground

The curtain wall system, added in the recent renovation, provides ample daylight into instructional spaces located on the building perimeter. Two isolated areas on the curtain wall south addition to the classroom wing were reported to have water leaks under certain wind conditions. The leaks were reported on west and east sides.

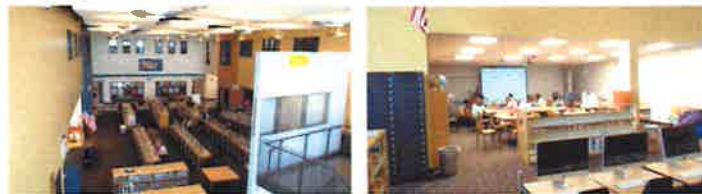
Building corridors are open to the Media Center on both floors. Sound is an issue at times when classes move between periods. The walls are mostly hard surfaces so sound travels easily and is reverberant. Separation or sound treatment is recommended for this space.

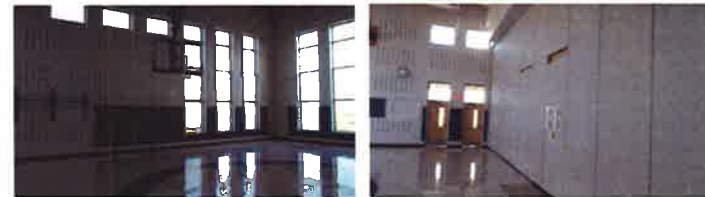
Gym

The gym equipment appears to be in good serviceable condition. The folding operable partition needs multiple repairs to correct broken bottom panel edges and some cladding panels are sliding out of position.
